## Property Inspection Report

**1234 Main Street, Houston TX 99999**

**Date of Inspection: 2/27/2000 Time: 8:00AM**

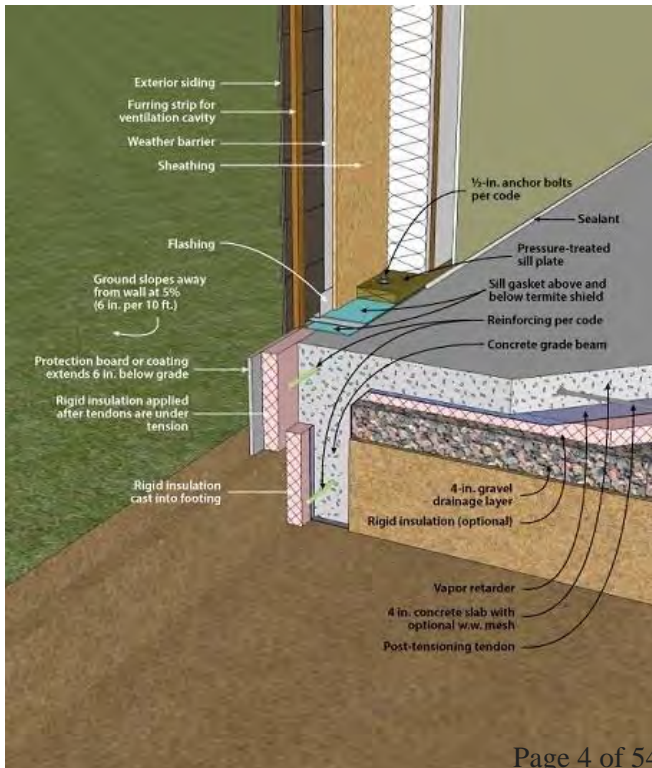
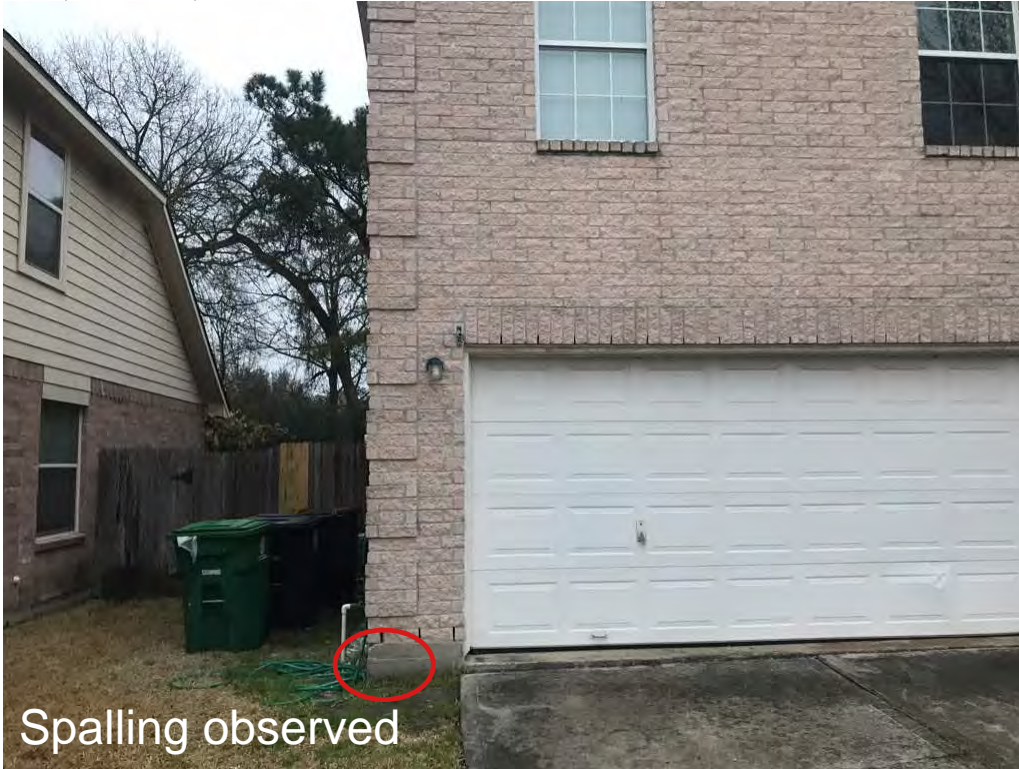
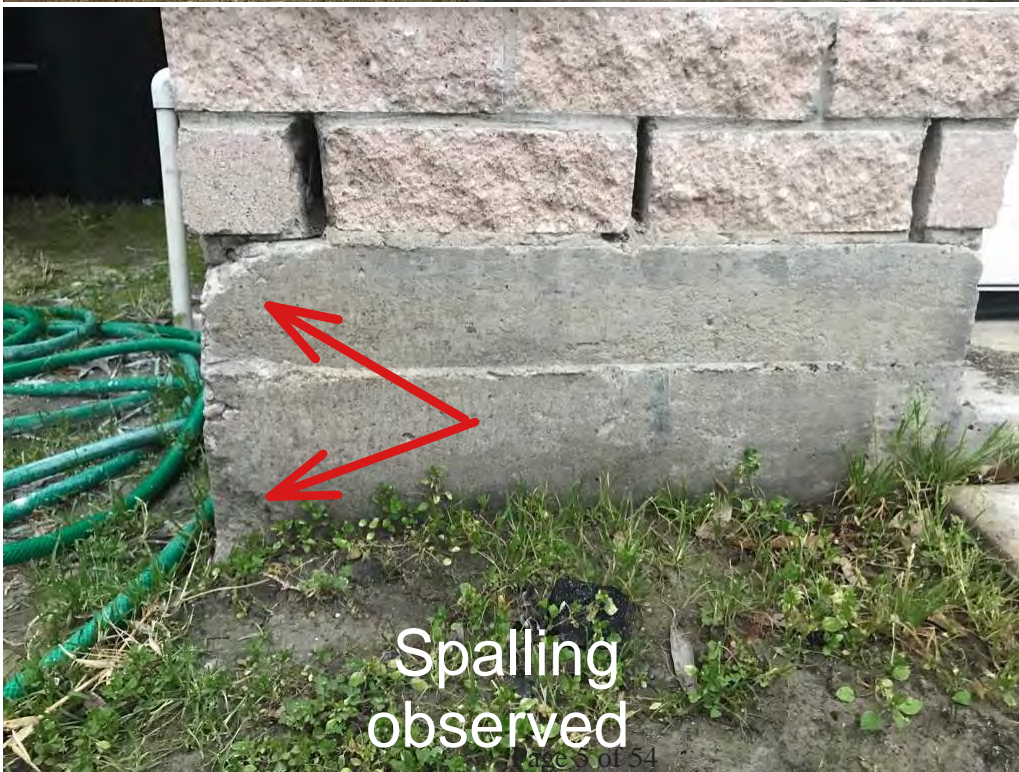
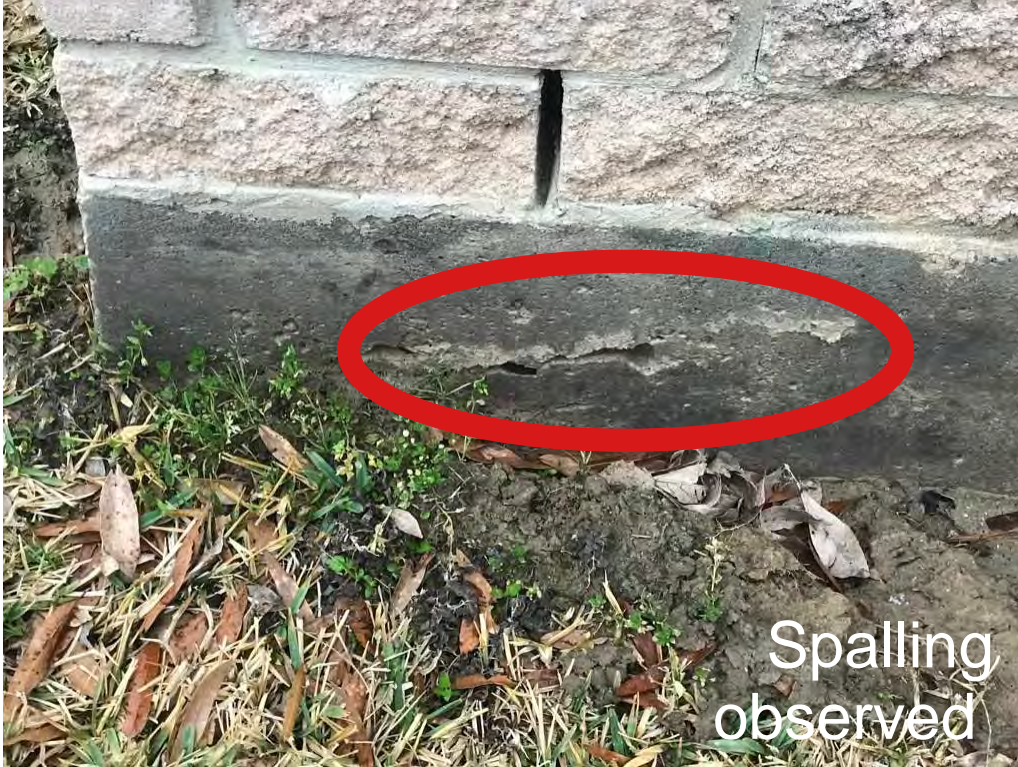
Spalling observed in at least one location at the time of inspection.

Spalling concrete is concrete that has broken up, flaked, or become pitted (oftentimes cosmetic in nature unless other movement is noted).

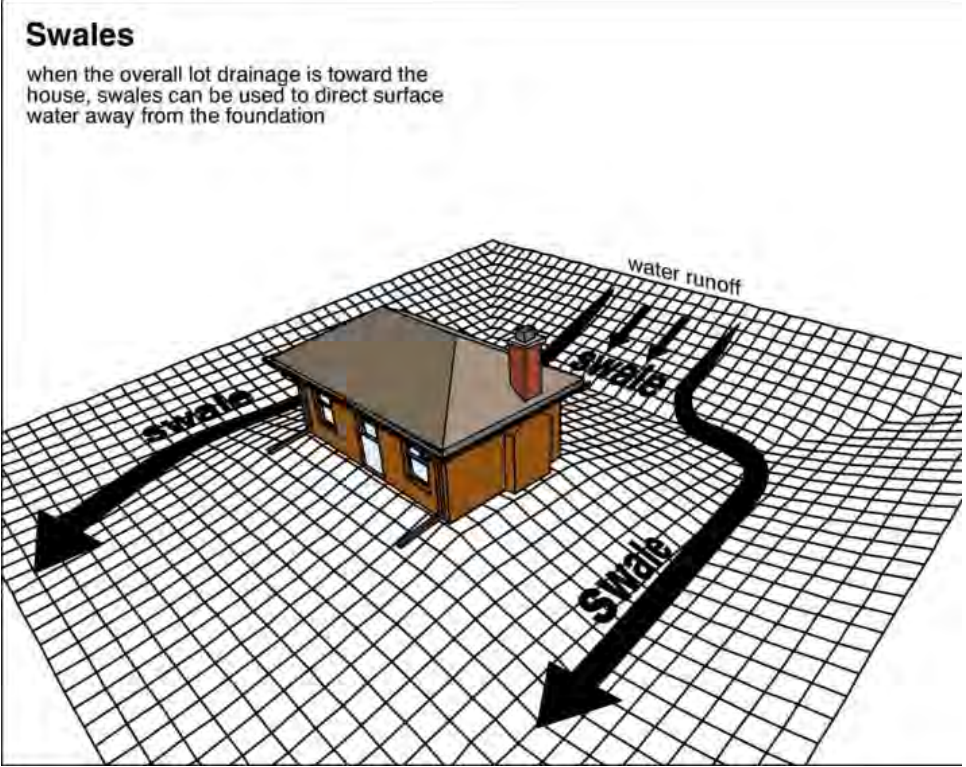
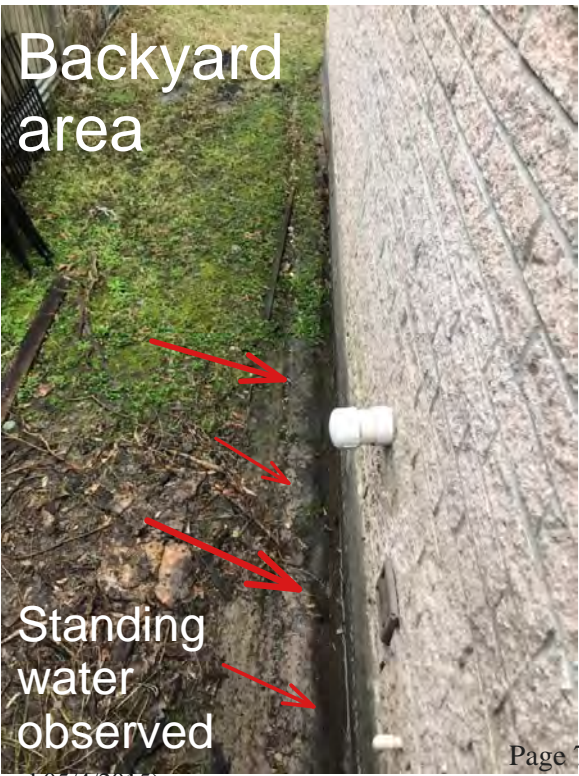
Grading has negative slope (at certain areas) towards property observed at time of inspection.

Negative slope can contribute to water collecting at foundation & foundation movement.

Correction recommended by qualified contractor.

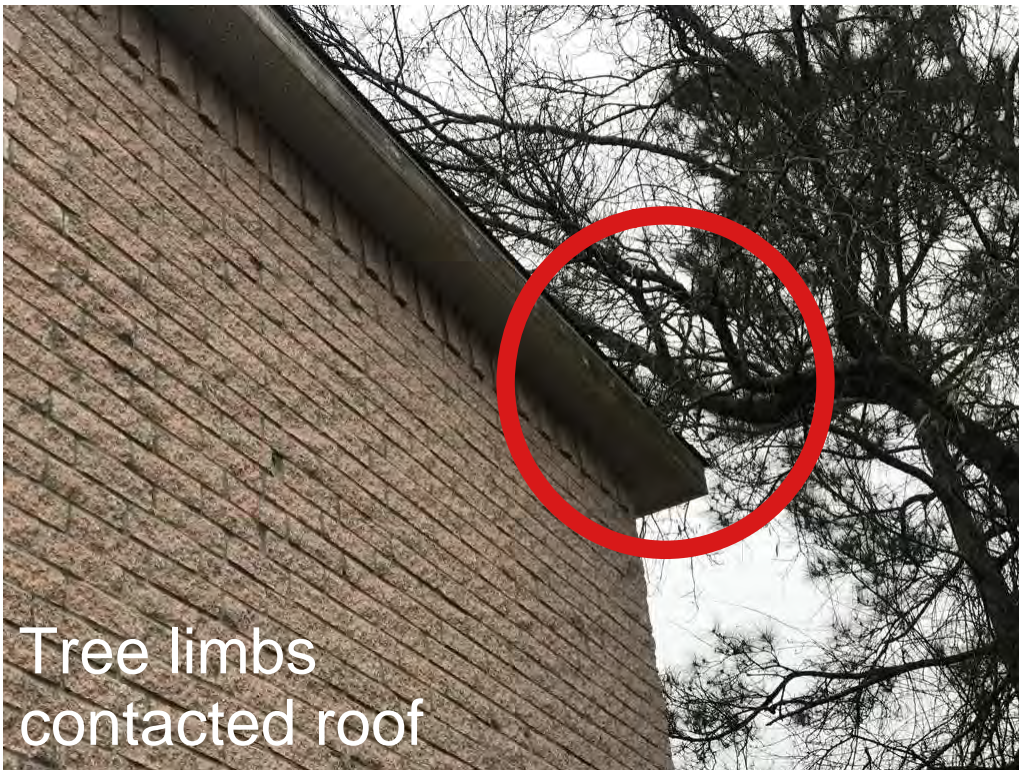
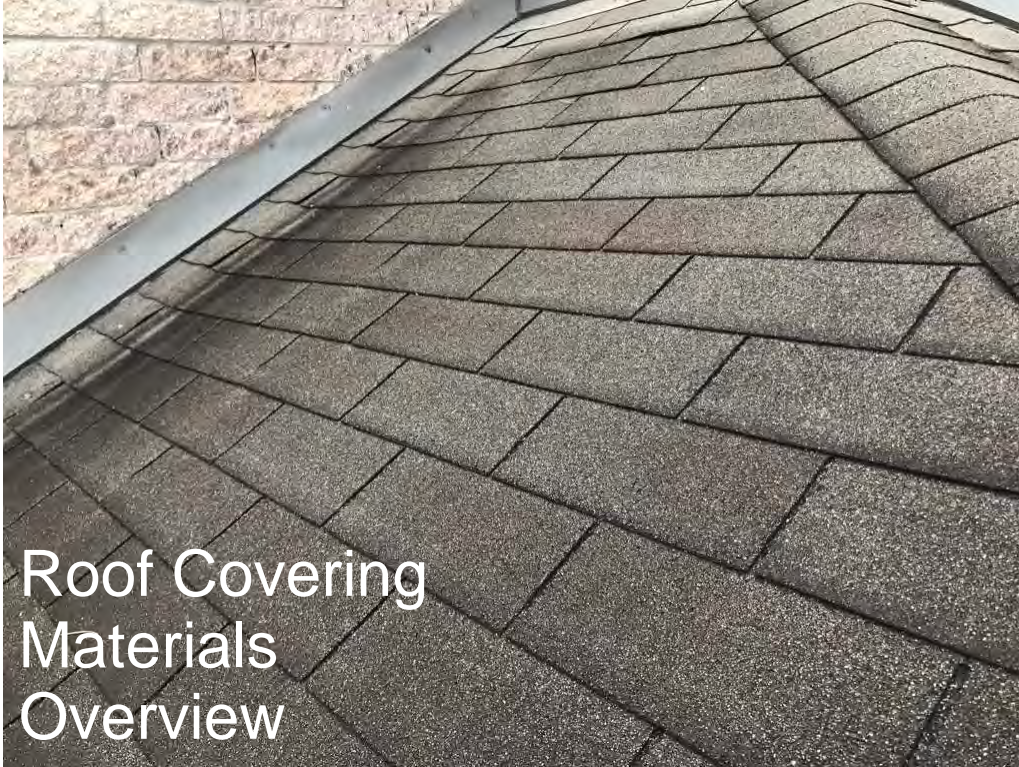
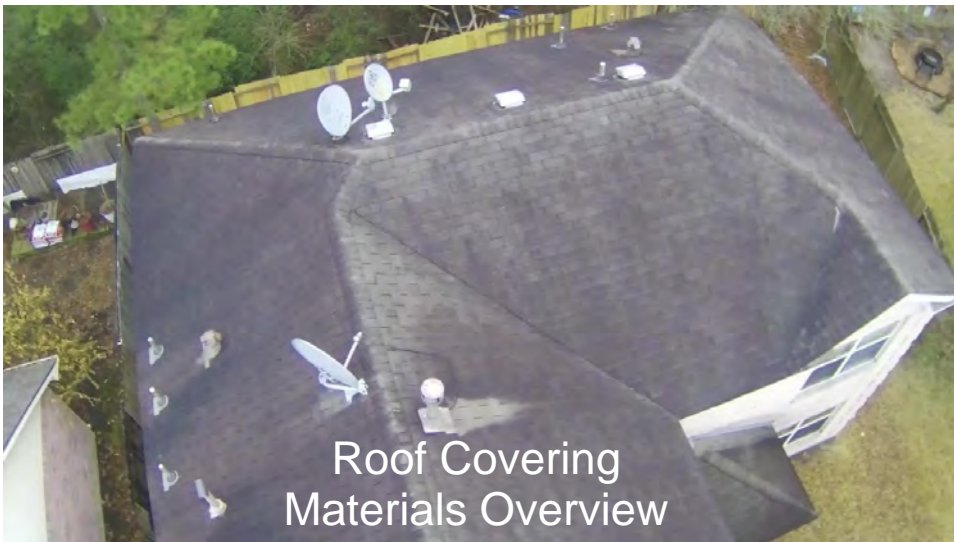
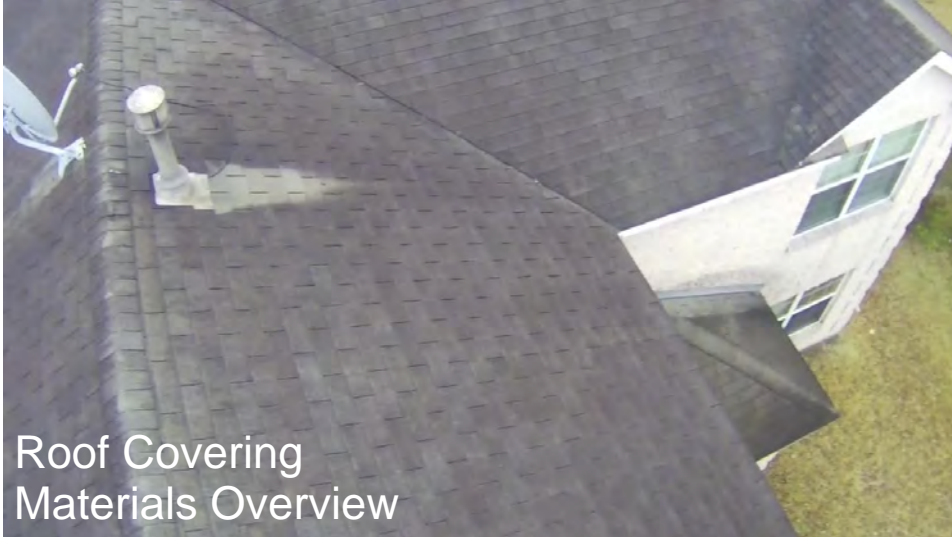
Tree branches contacting roof of property.

Inspector recommends that all tree branches be cut back so that they do not overhang the roof.

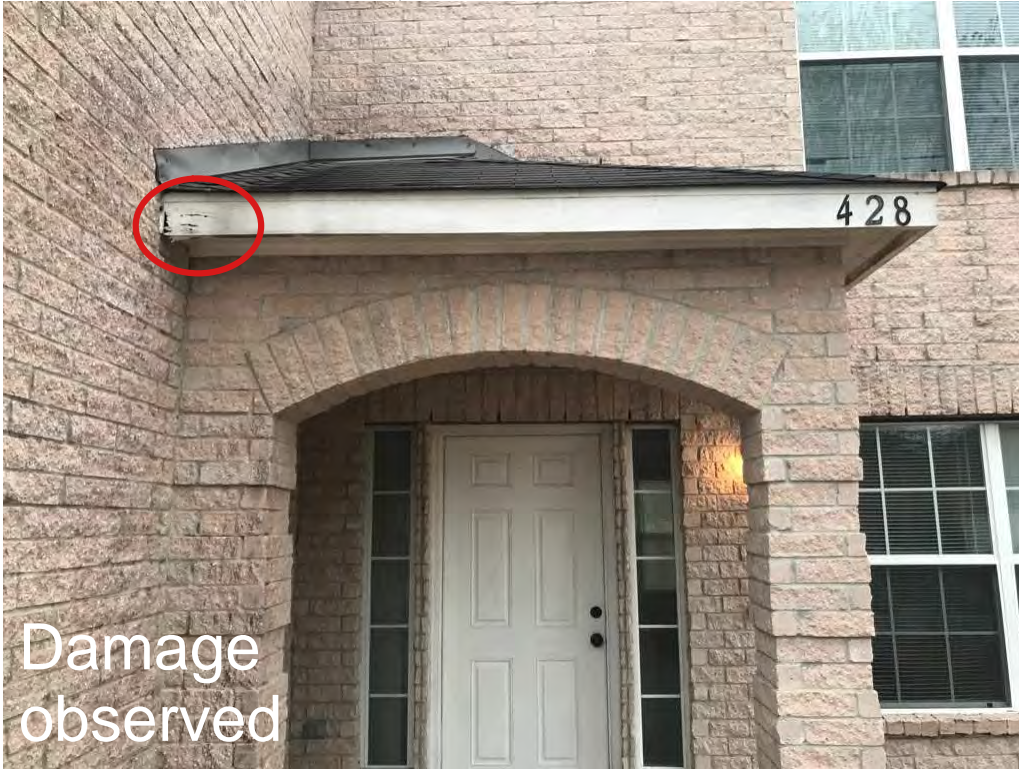
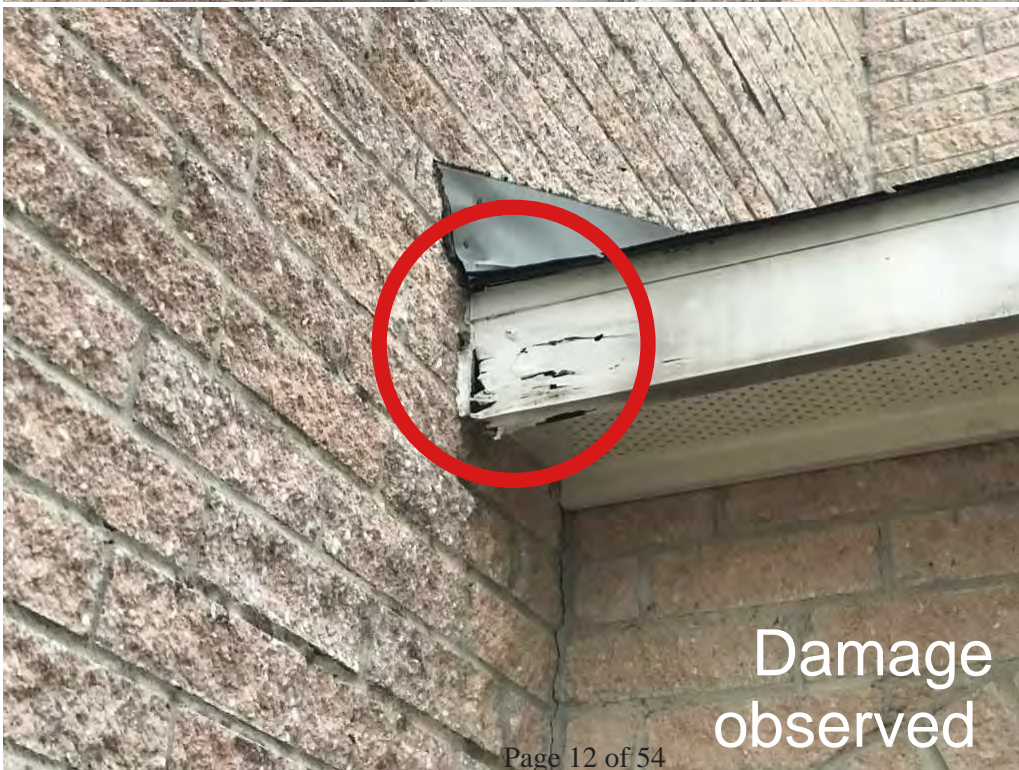
Damaged wall covering (exterior) observed.

Correction recommended to minimize possibility of moisture / pest intrusion.

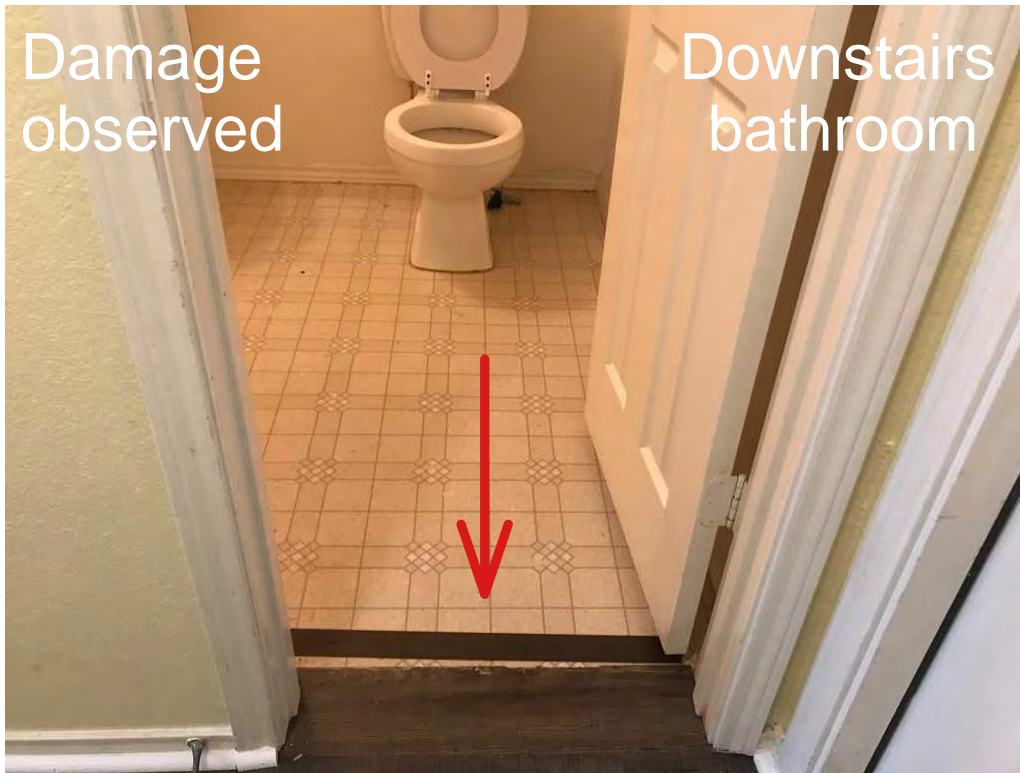
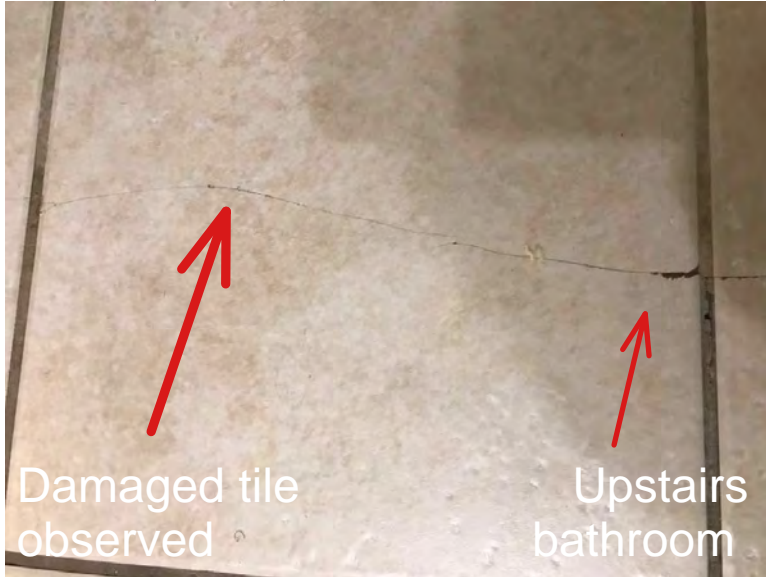
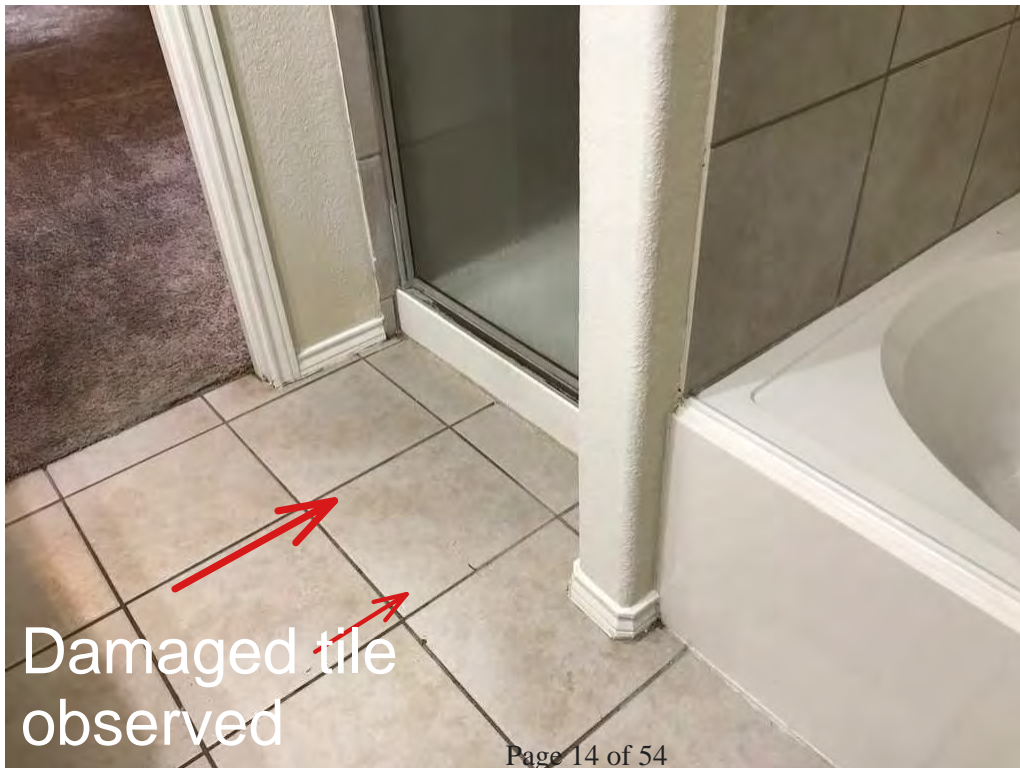
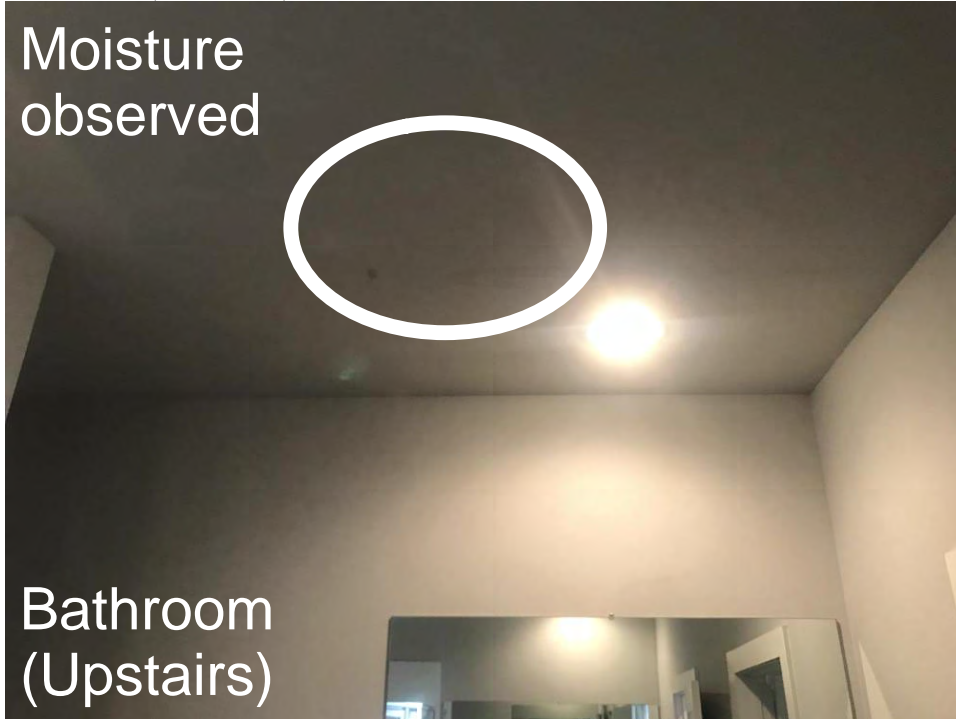
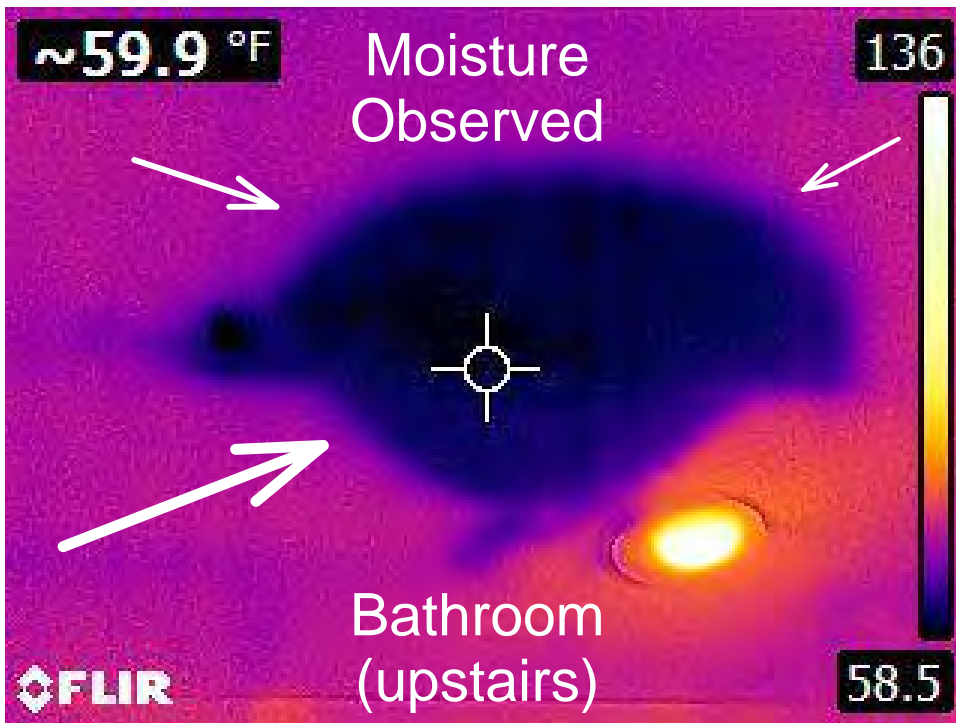
1. Damaged flooring transition observed (downstairs bathroom).

2. Cracks in floor tiles observed in bathroom (upstairs).

Correction recommended by qualified contractor

Monitor and correction recommended by qualified contractor if further movement observed.

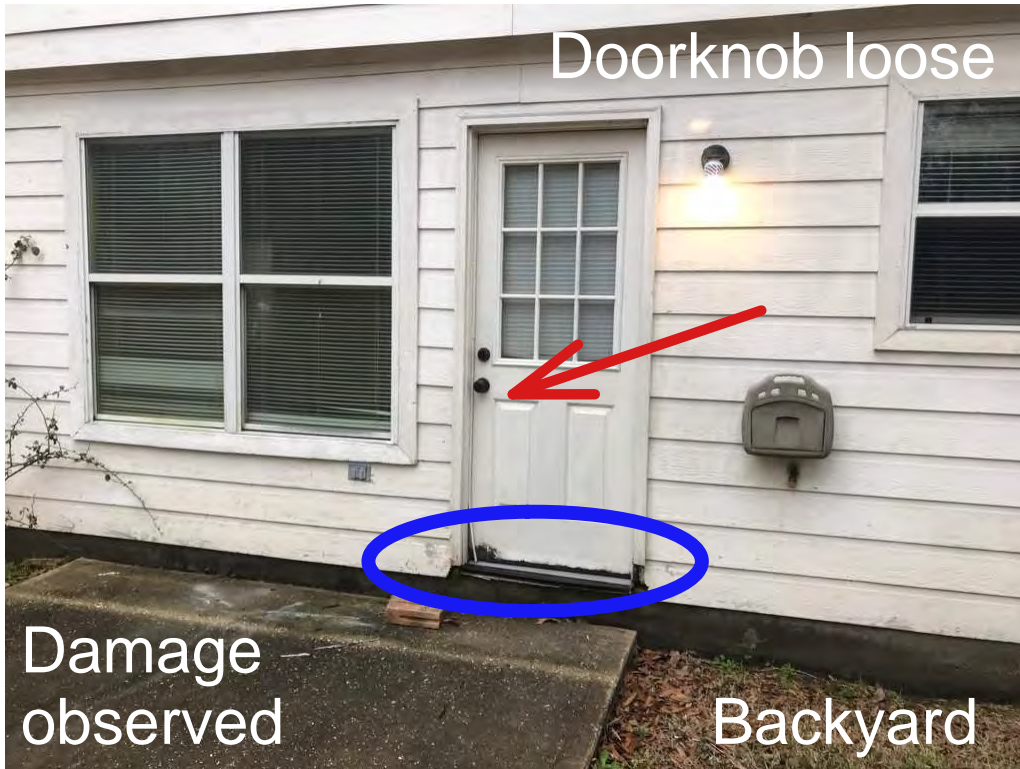
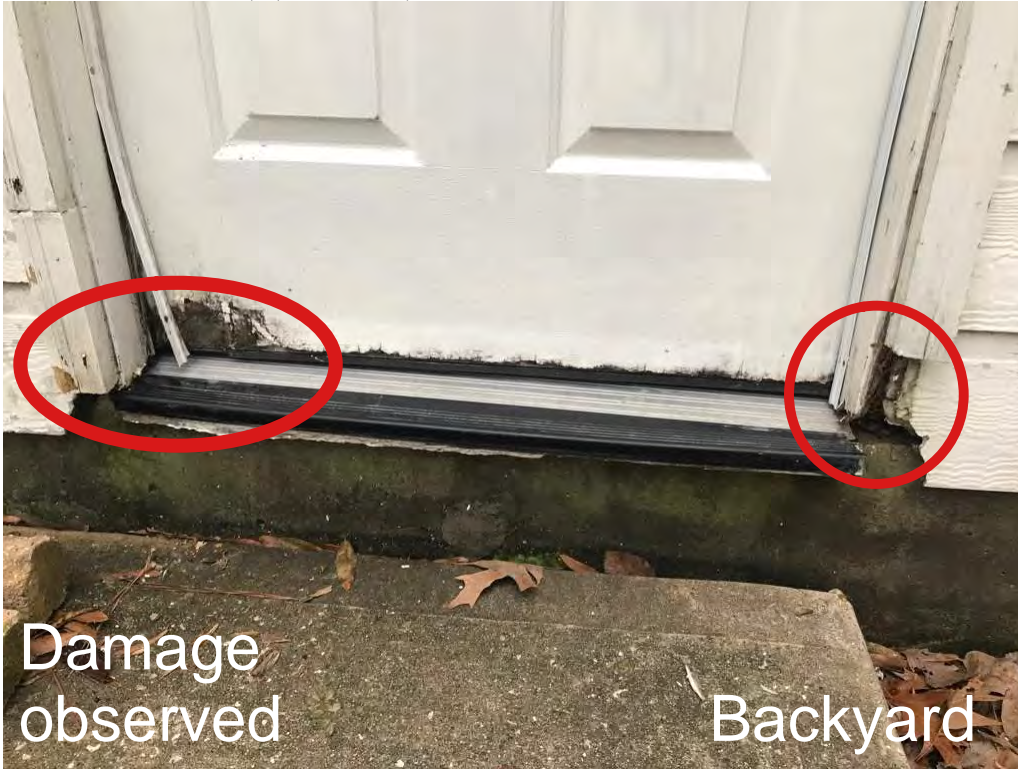
1. Damage observed at door to backyard & doorknob loose.

Correction recommended by qualified contractor.

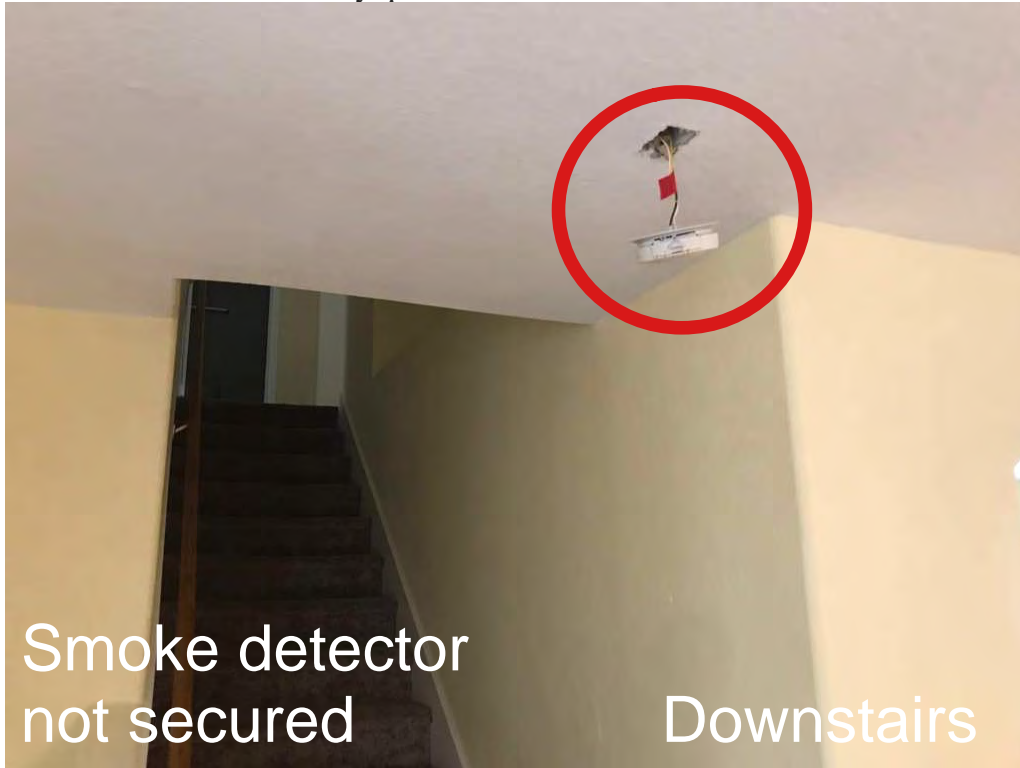
Smoke detector not secured to ceiling (downstairs / stairway area).

Correction recommended by qualified contractor

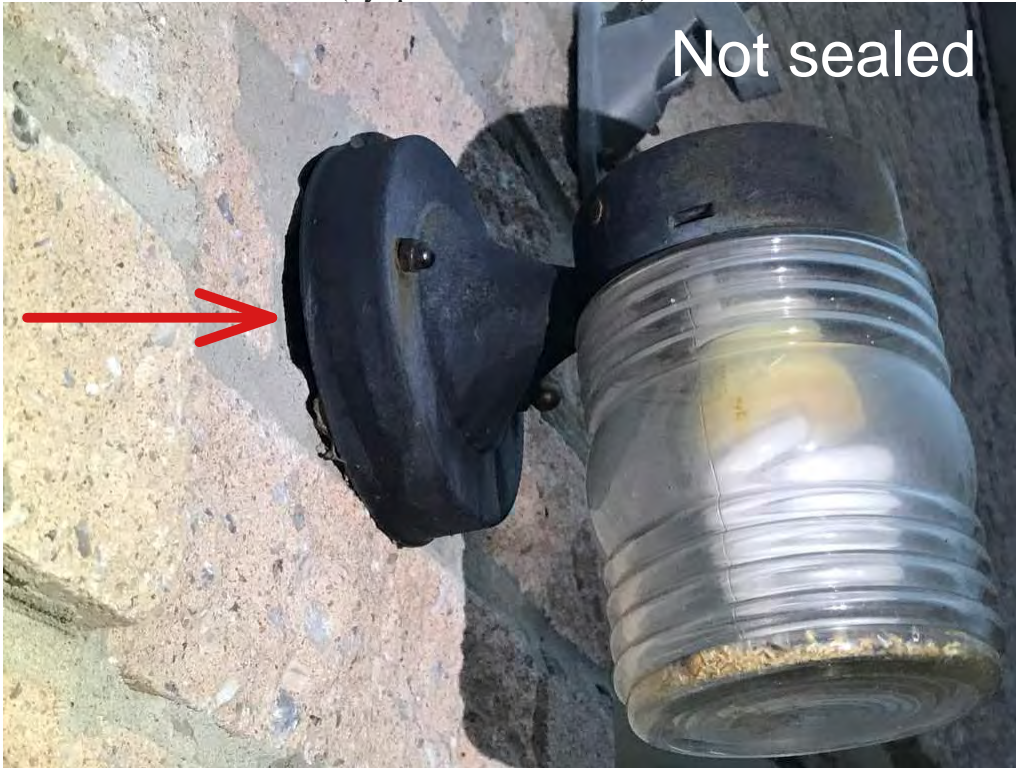
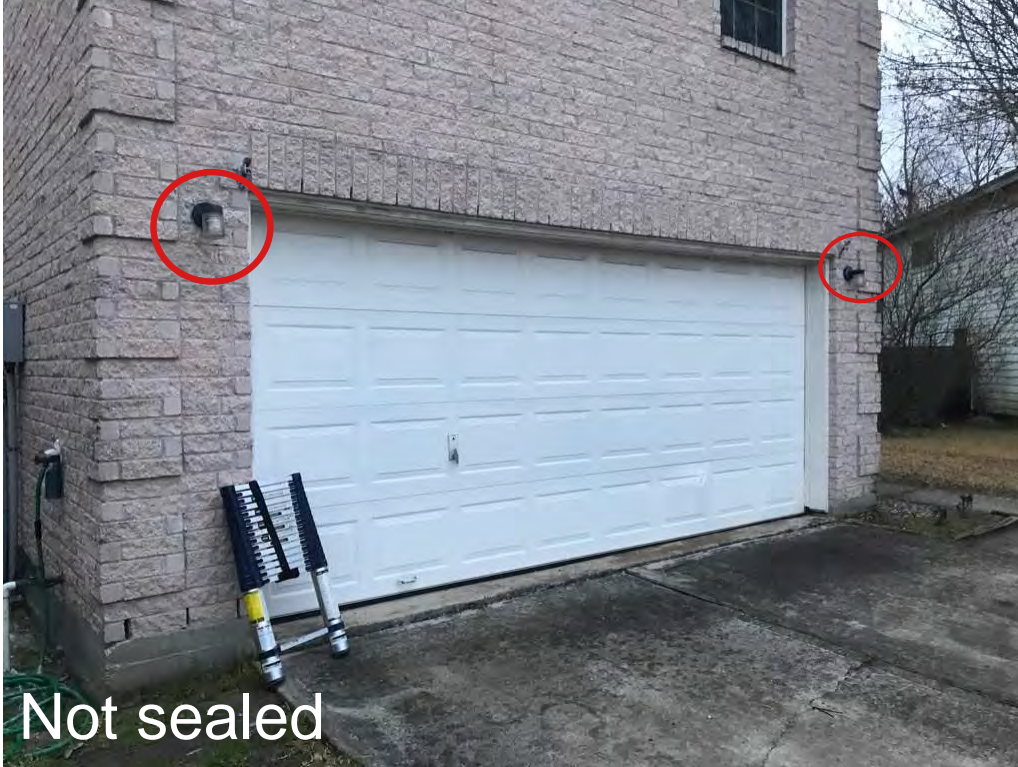
Light fixtures (exterior) were not sealed completely at wall covering.

Correction recommended (by qualified contractor) to limit moisture intrusion.

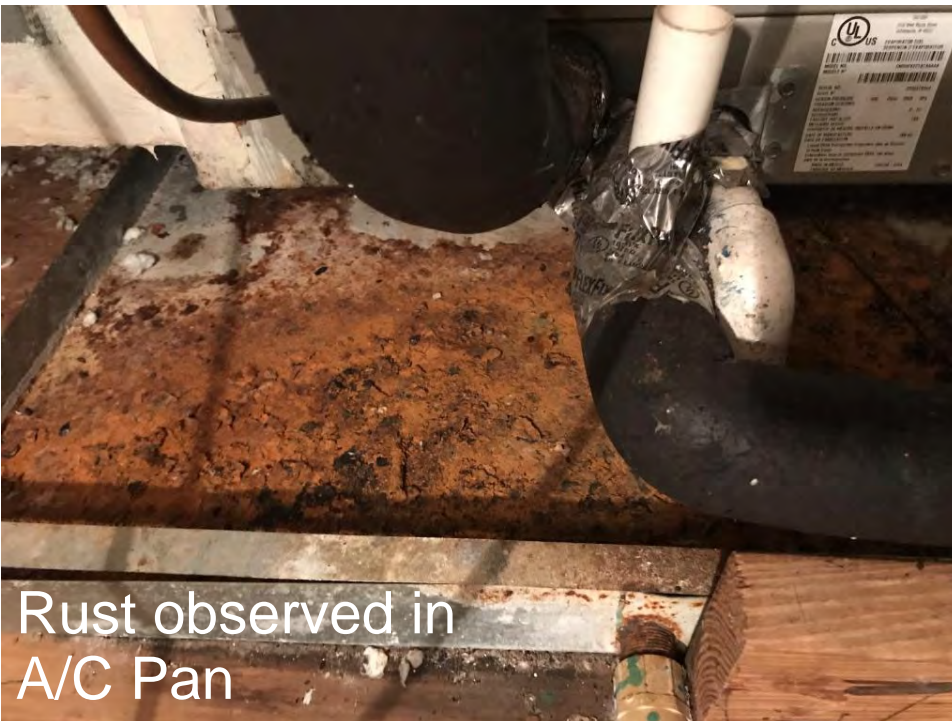
1. Rust observed in overflow pan.
2. A/C Unit 2006 Model (15 years old).

Rust observed in  
A/C Pan

It is recommended that all A/C and furnace units more than 10 years of age be evaluated by a licensed A/C and heating specialist (home inspector is not licensed A/C and heating specialist).

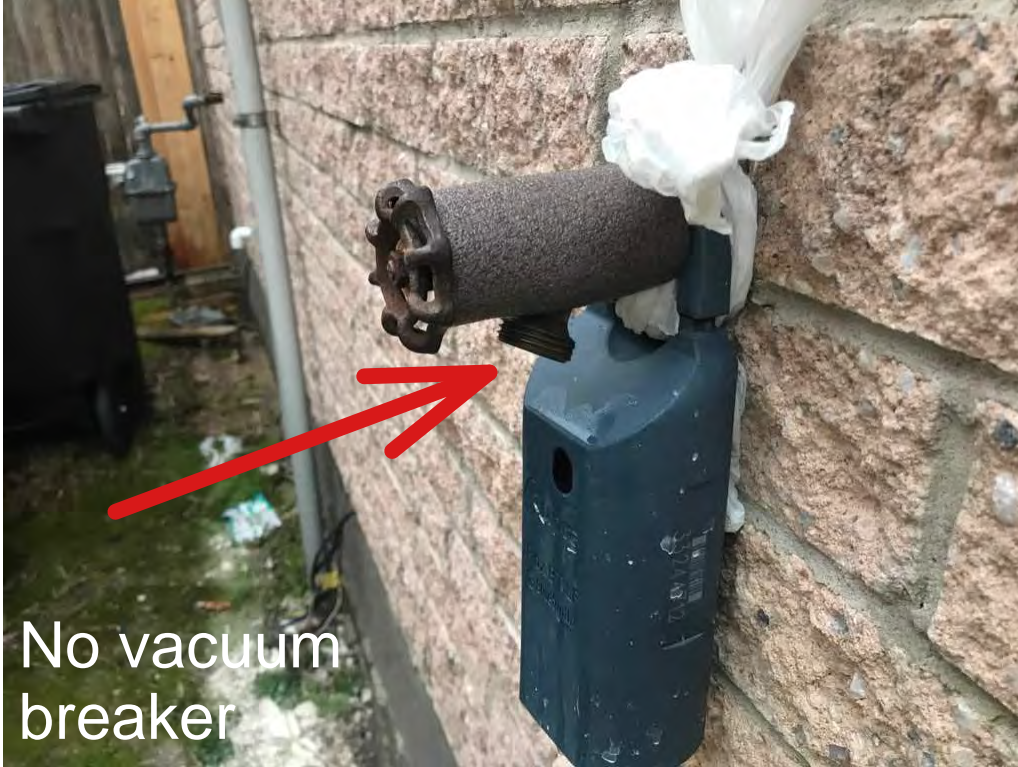
No vacuum breaker

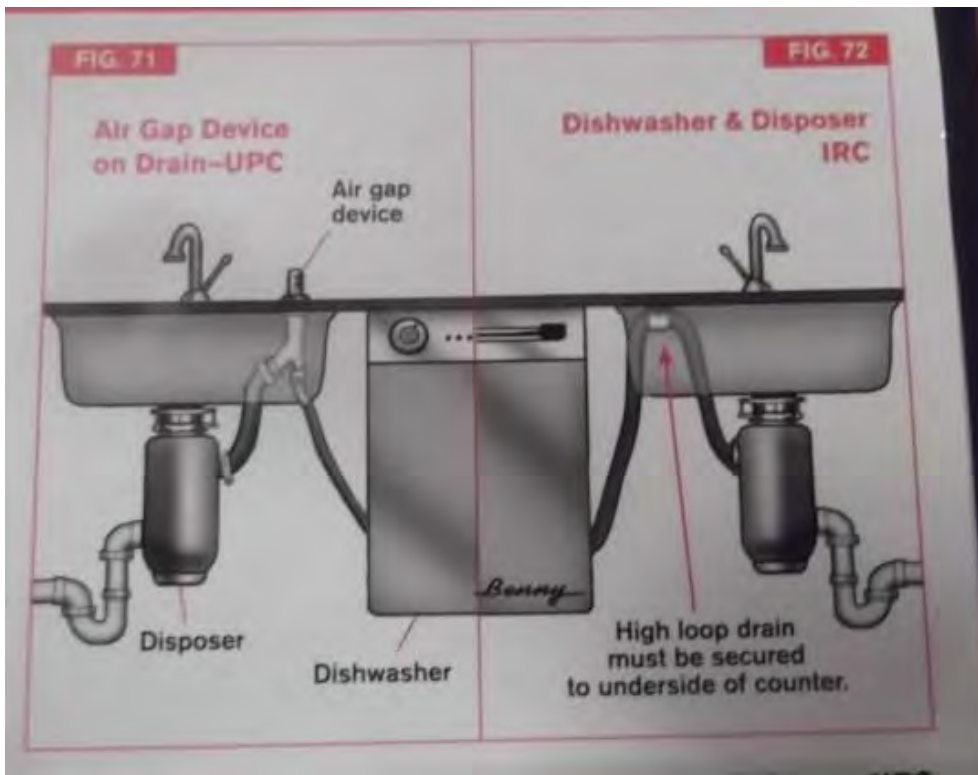
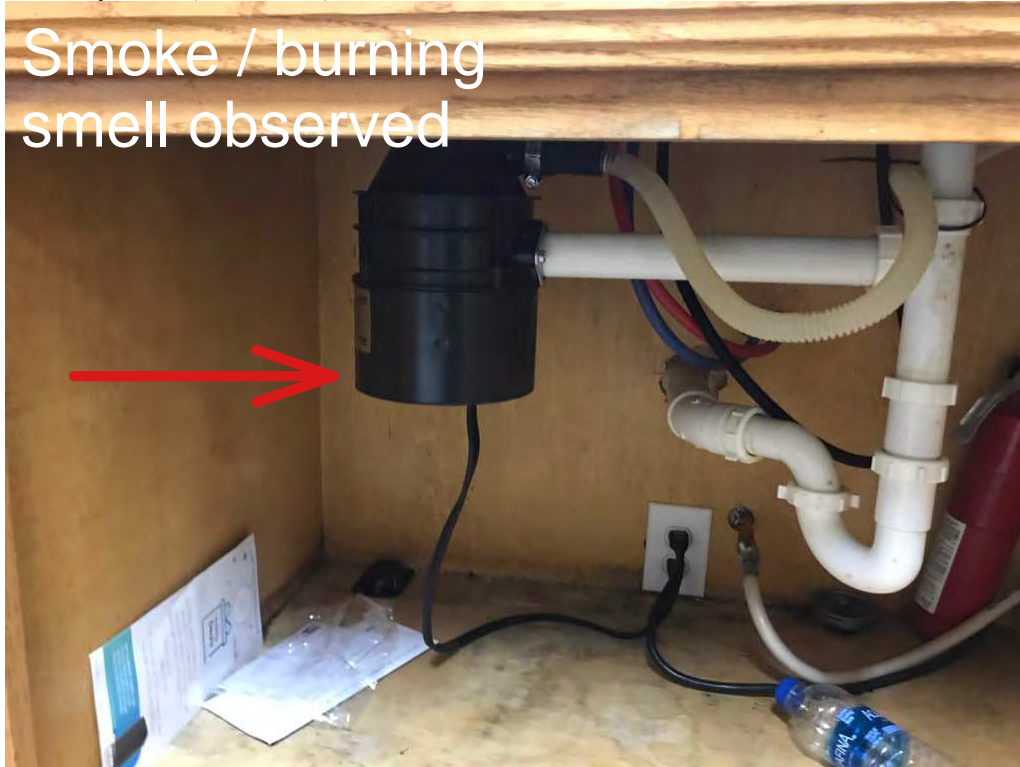
Smoke / burning smell coming from food waste disposal

Further evaluation and correction recommended by qualified contractor
