1234 Main Street  
Spring TX 77386

# PROPERTY INSPECTION REPORT FORM

| Lukas Kyle<br><i>Name of Inspector</i> | TREC ID# 25889<br><i>TREC License #</i> |

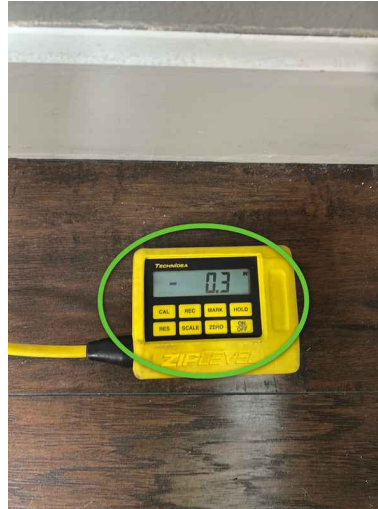
Digital foundation analysis within tolerance

Digital foundation analysis diagram

*The foundation appears to be supporting the structure as intended at the time of inspection:*  
The foundation appears to be supporting the structure as intended at the time of inspection

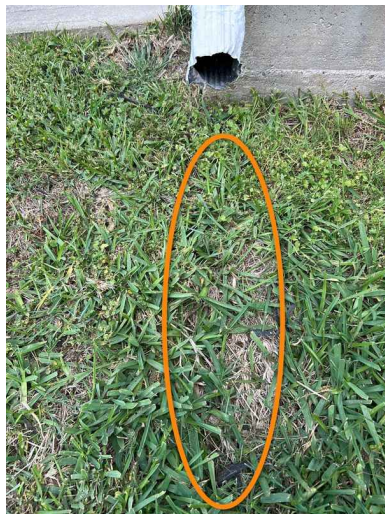
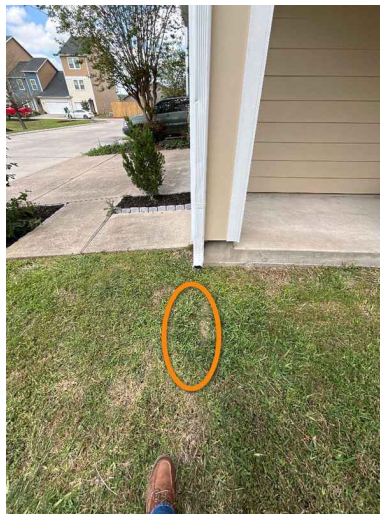
One or more splash blocks/extensions were observed as missing at the discharge of the gutter downspouts. This can create unnecessary erosion of soil in close proximity of the foundation. Recommend evaluation by a qualified contractor and remedy as needed.

Splash Block / Extension Missing

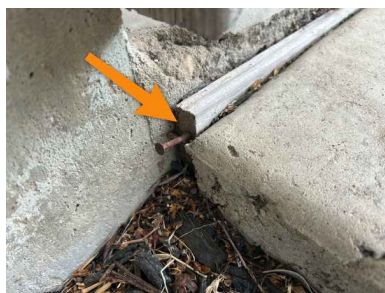
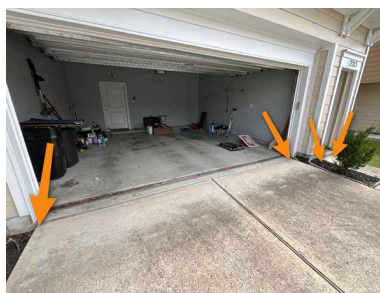
Wood to ground contact is a conducive condition for termites and other wood destroying insects per Texas Department of Agriculture even if wood is treated or cedar.

Wood to Ground Contact

Correction is recommended by a qualified contractor to minimize possible future infestation.

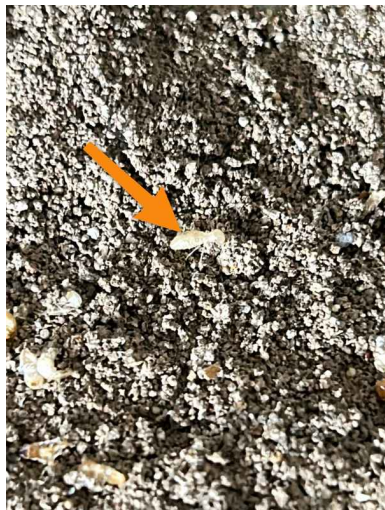
Active termites observed at the time of inspection.

Active Termites

Further evaluation and correction is recommended by a licensed pest control professional.

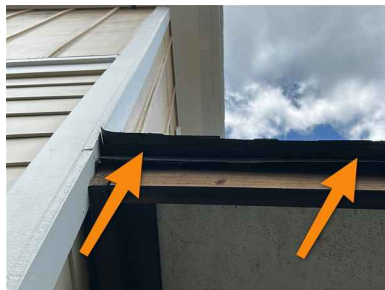
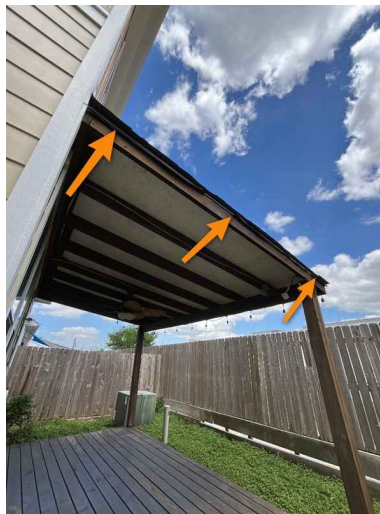
Observed roof covering materials with an excessive drip edge.

Drip edge overhang recommended to be a maximum of 1 inch.

Excessive Drip Edge

Correction is recommended by a qualified contractor to minimize possible moisture damage.

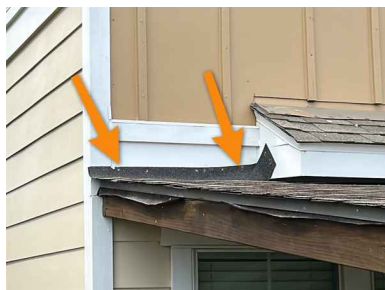
Observed missing counter, flashing at one or more areas at roof covering material.

Missing Counter flashing

Correction is recommended by a qualified contractor to minimize possible moisture intrusion.

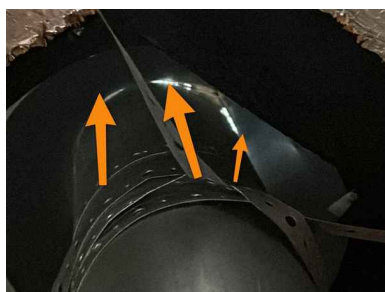
Observed an excessive gap at one or more locations

Excessive gap

Correction is recommended by a qualified contractor to minimize possible pest and moisture intrusion.

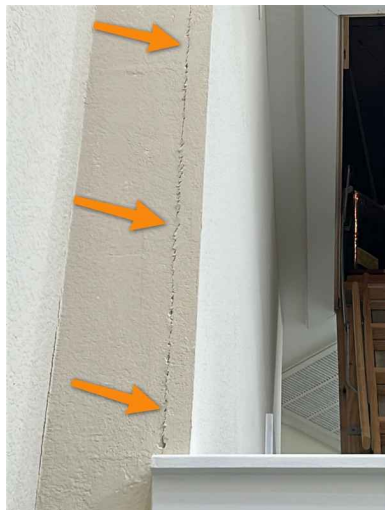
Peeling/cracked texture observed at one or more locations at interior wall covering.

Peeling/cracked texture can be indication of structural movement or common settlement cracking.

Peeling Cracked Texture

Further evaluation and correction is recommended by a qualified contractor.

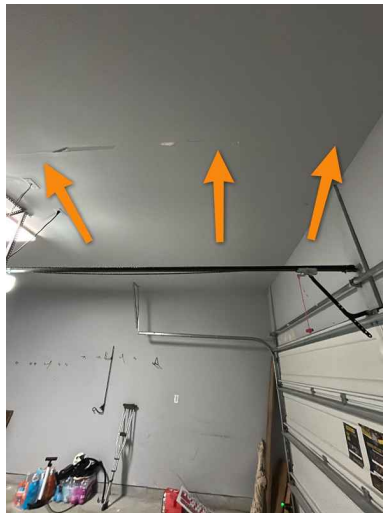
Observed peeling / cracked ceiling texture.

Peeling / cracked ceiling texture can indicate normal wear or more significant structural deficiency.

Peeling/Cracked Ceiling Texture

Further evaluation and correction recommended by qualified contractor.

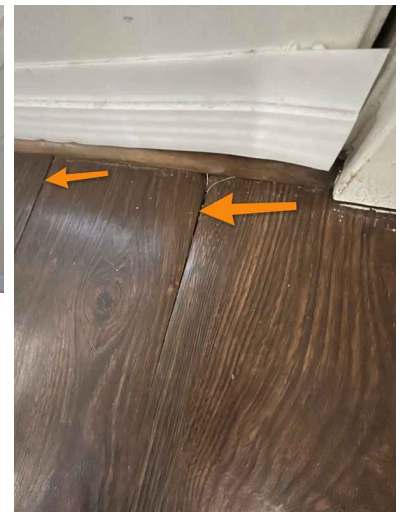
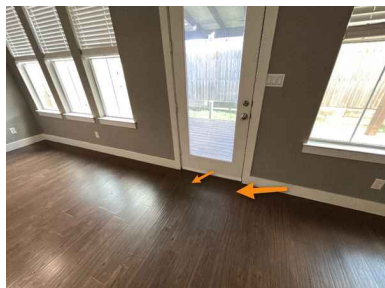
The home flooring had moisture damage visible at flooring and baseboards at the time of the inspection. Recommend evaluation by a qualified flooring contractor.

Flooring -Moisture Damaged

Flooring-Moisture Damaged

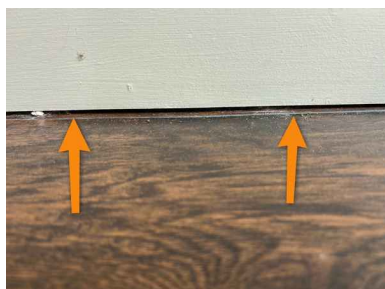
Flooring Not Sealed at Baseboard Interface

Correction recommended by qualified contractor to minimize possible moisture intrusion

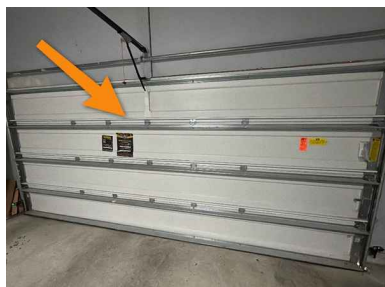
Garage overhead door very hard to open and close. Correction recommended by a qualified contractor.

Garage door very hard to open and close

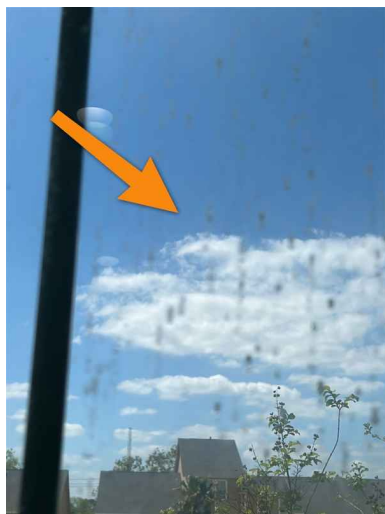
Observed condensation between the window panes, which indicates a failed thermal seal. Correction recommended by qualified contractor to ensure proper functionality of double paned window.

Failed Thermal Seal

Recommendation: Contact a qualified window repair/installation contractor.

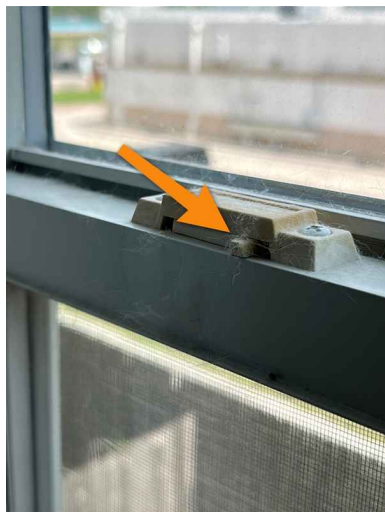
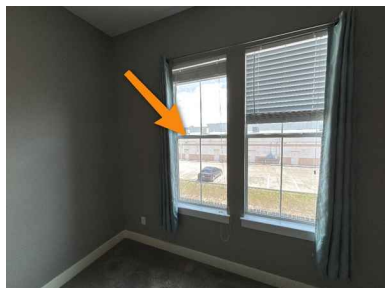
Window lock hardware damaged / not installed (multiple windows).

Damaged Lock

Correction recommended by qualified contractor.

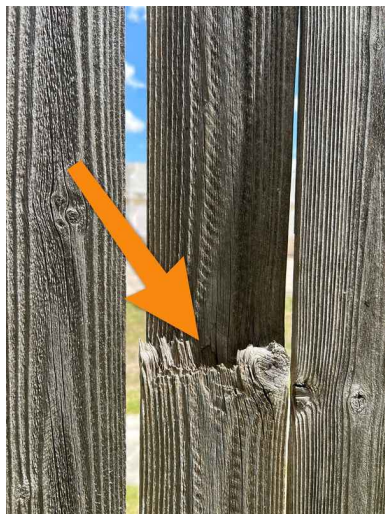
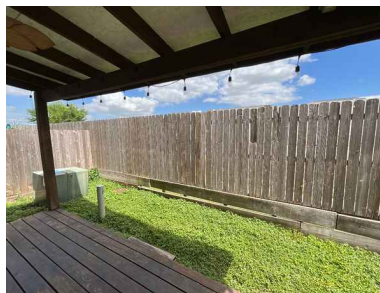
Observed damaged fence pickets / posts at one or more areas of the fence.

Damaged Fence Pickets

Correction is recommended by a qualified contractor.

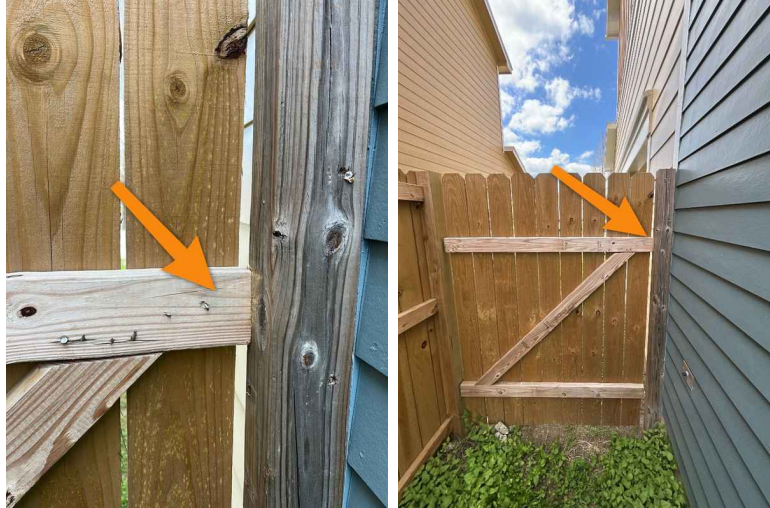
Observed Fence gate not openable from inside the backyard,

Fence Not Openable From Inside

Correction is recommended by a qualified contractor to ensure proper exit of backyard.

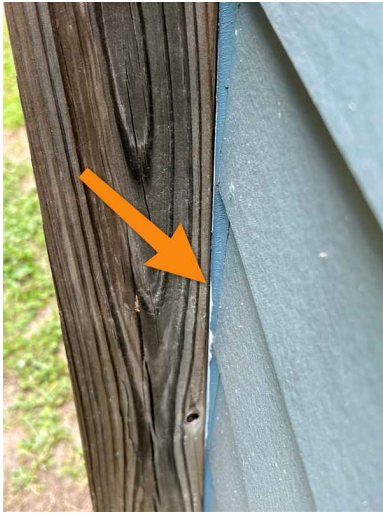
Wood fence in contact with structure was observed at one or more areas.

Wood fence in contact with structure is a conducive condition for wood destroying insects per Texas Department of Agriculture.

Wood Fence in Contact with Structure

Correction is recommended by a qualified contractor to minimize possible future infestation.

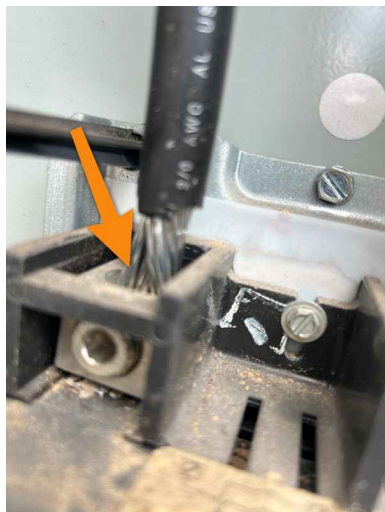
No anti-oxidant paste observed at main electrical aluminum cables in panel.

Anti oxidant paste is recommended for aluminum cables because (without the paste) aluminum can overheat & become fire hazard.

No Antioxidant Paste

Further evaluation & correction recommended by qualified contractor.

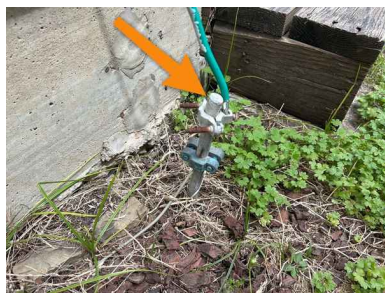
Ground Rod not Embedded

Correction recommended by qualified contractor.

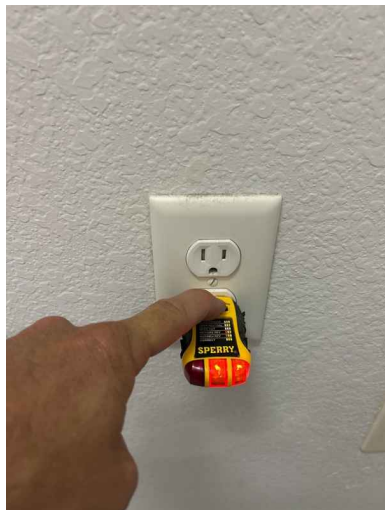
Missing GFCIs observed at time of inspection (kitchen, bathrooms, & unconditioned areas).

GFCIs are recommended for fire & electrical shock prevention.

Missing GFCI Protection

Correction recommended by qualified contractor.

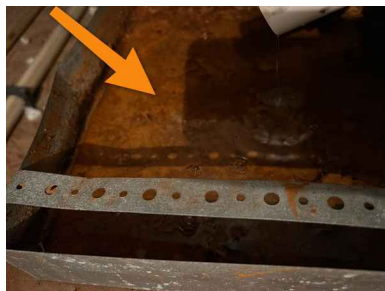
Moisture observed in A/C overflow pan.

Moisture in A/C overflow pan often indicates blockage of primary condensation drain line.

Moisture Observed in Overflow Pan

Further evaluation and correction recommended by qualified contractor.

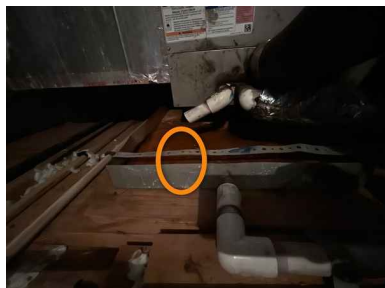
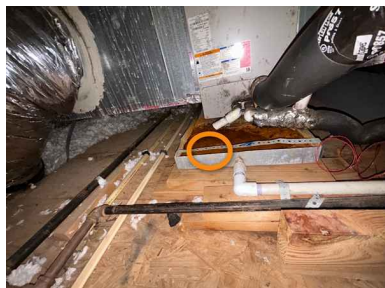
No float / kill switch observed installed at AC overflow pan

A float / kill switch sits in the AC overflow pan and shuts the unit off if moisture detected in overflow pan.

No Float/Kill Switch

Correction recommended

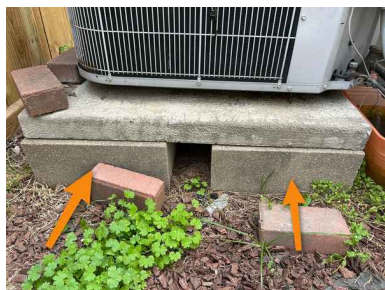
Observed improper support at AC pad at the time of inspection.

It is recommended to have a solid pad/surface for AC to sit on.

Improper Platform / Pad Support

Correction is recommended by a qualified contractor to minimize a possible movement of AC unit.

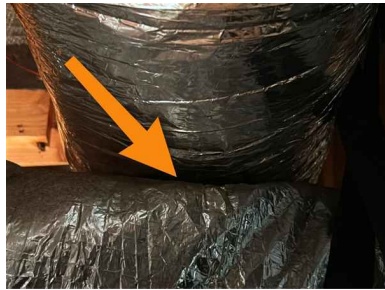
Observed multiple areas (in attic) where flex duct touched & or missing required 1 inch clearance from other ducts.

Ductwork Touching

Further evaluation & correction recommended by qualified contractor.

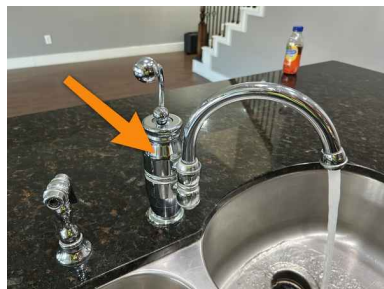
Observed loose or damaged faucet hardware.

Loose/Damaged Faucet

Correction recommended by qualified contractor.

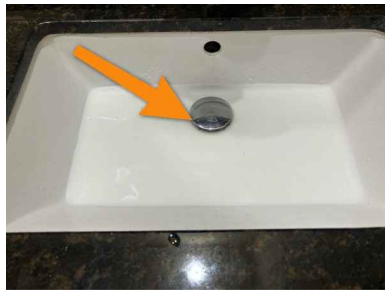
Observed sink draining slowly in bathroom.

Draining Slowly

Further evaluation & correction recommended by qualified contractor.

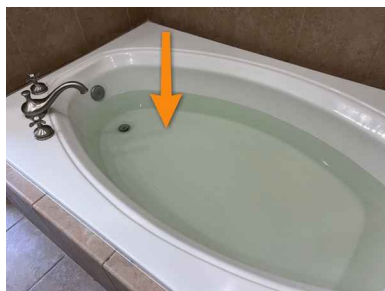
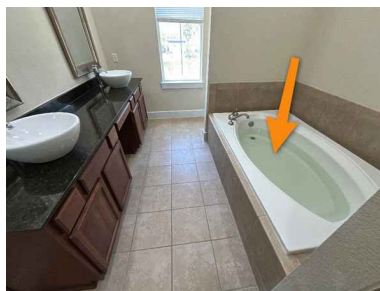
Observed bathtub tub/shower draining slowly at the time of inspection.

Slow drain

Further evaluation and correction is recommended by a qualified contractor to ensure proper functionality of bathtub drain.

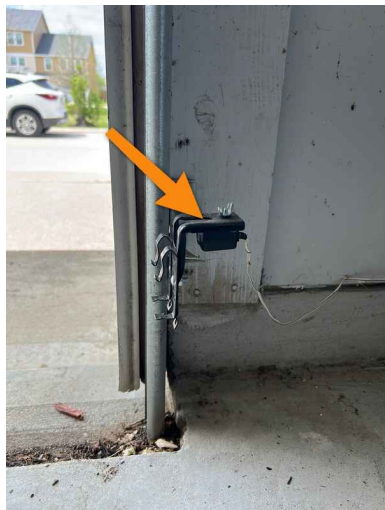
Observed auto reverse safety sensor too high - safety item.

Auto-reverse Sensor too High

Correction recommended by qualified contractor
